## Reinforced Soil Walls: Rebuilding Confidence

**Goel Rajiv, MD**  
**Earthcon Systems (India) Pvt. Ltd.**  
*earthcon\_systems@rediffmail.com*

India has undertaken large infrastructure up-gradation projects and Reinforced Soil Walls are being widely used for retaining high embankments. With burst of activities, some hard experiences are bound to come by. Incorrect implementation of the design and construction practices has given the technology a bad name. Also the general feeling with the contractors is that this is a resource intensive technique coupled with underutilisation of the same. Many highway projects have got delayed due to non-timely completion of reinforced soil structures. The unfavorable scenario is also preventing any innovation to see the light of the day which, in addition to preventing some of the failure modes, can also possibly simplify the construction a lot.

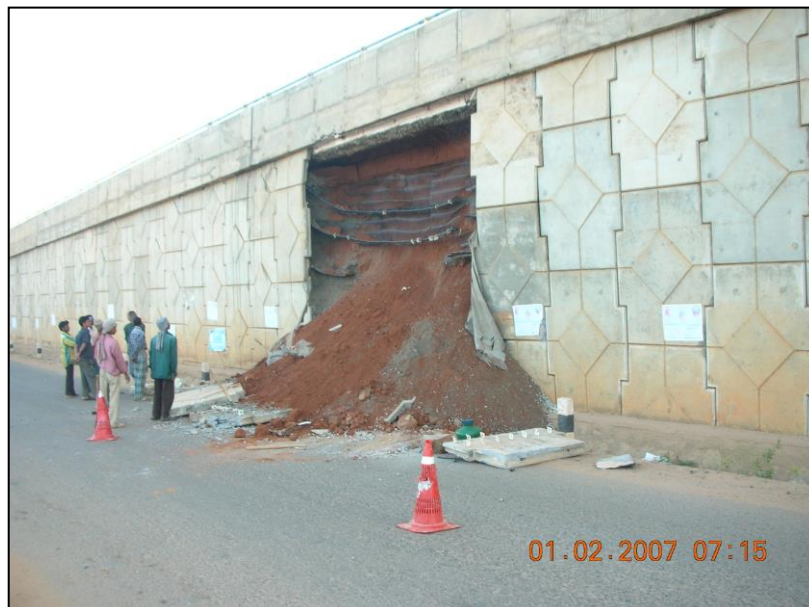
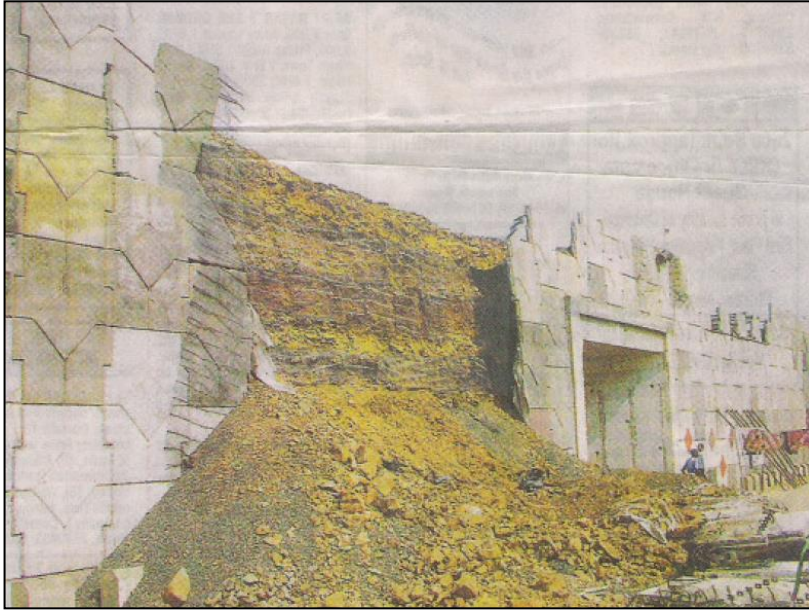
This is the most common type of failure which has been experienced and documented worldwide including India. By its inherent nature this is not a failure of the reinforced earth mass but a loss of skin to the mass due to various reasons. Excessive rainfall has been a major cause of distress due to pore water pressure development coupled with sand blow through the facia joints. Differential settlement occurs on account of soil loss and/or poor compaction of backfill, resulting in reinforcing element- facia connection snapping. External damage to the facia can also cause this type of failure. Few of the photos given below represent the failure.

#### **Photo 1 and 2: Two Cases of Facia Panel Separation**

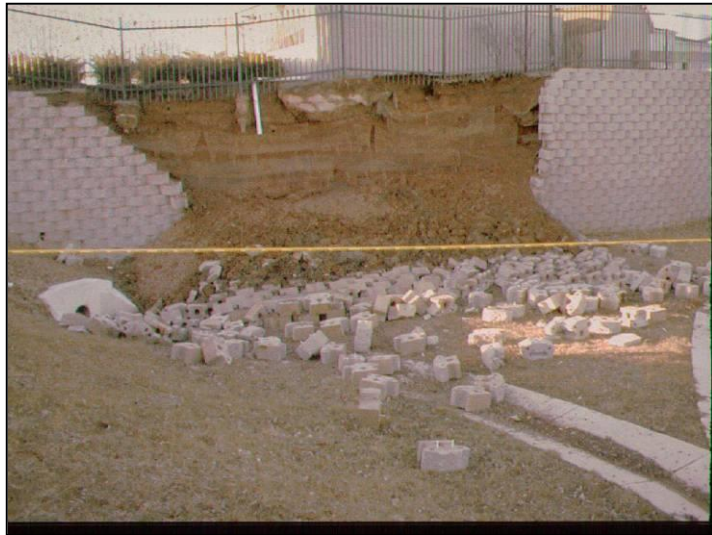
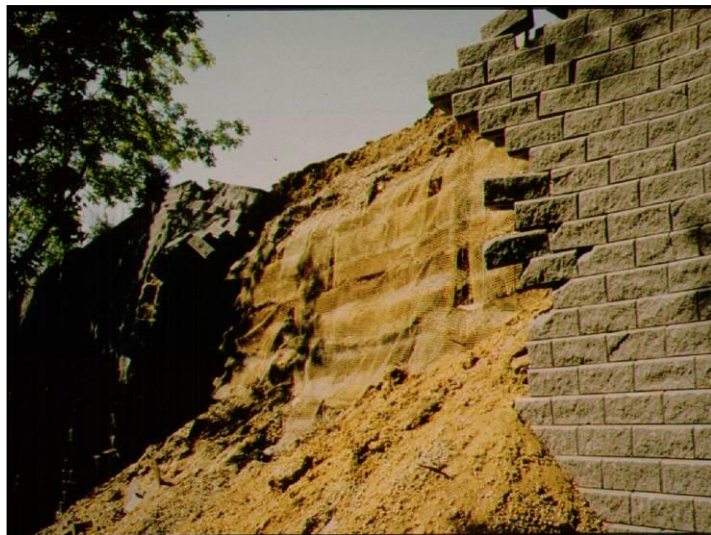
**Photo 3 and 4: Two Cases of Modular Block Separation**

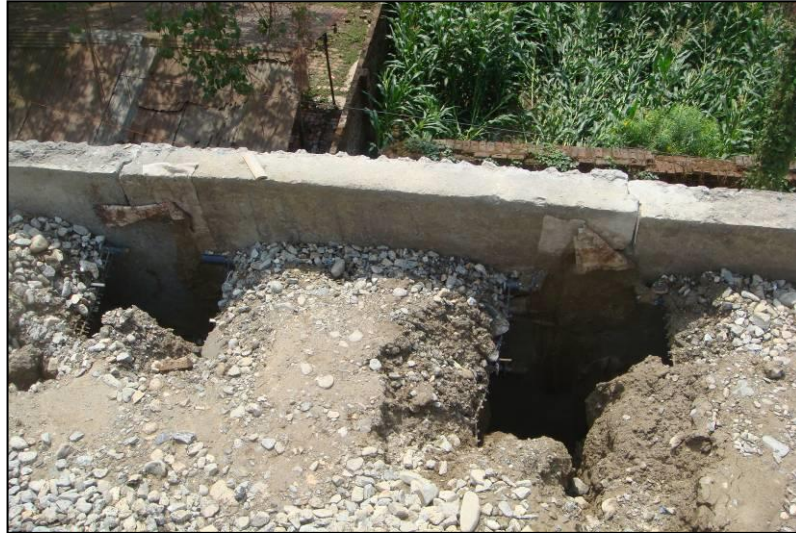
**Photo 5: Case of Sand Loss Due to Rainwater**

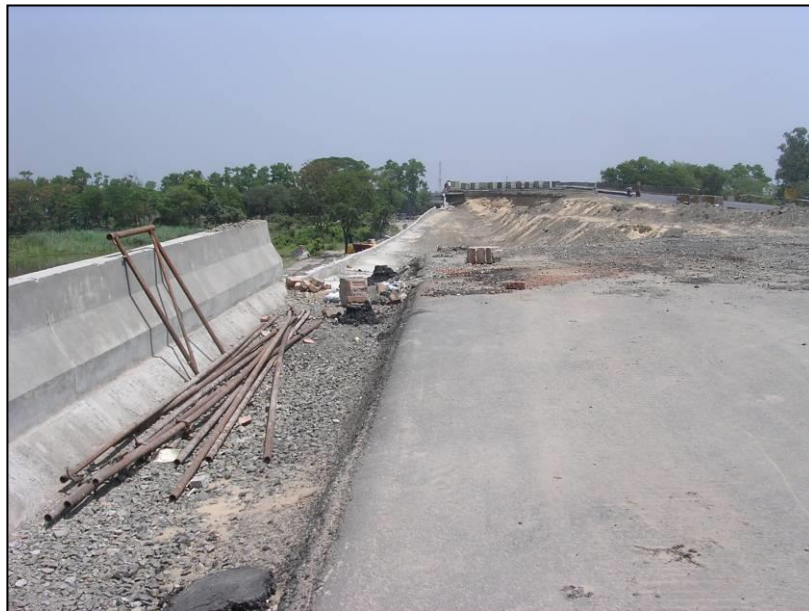
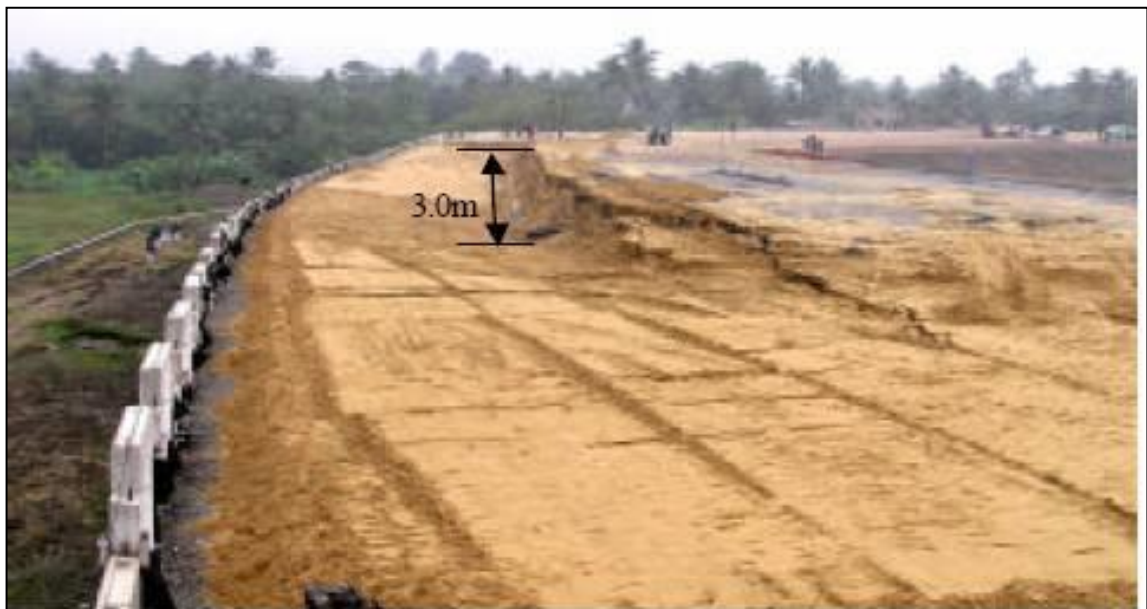
This type of failure is not very common and can result only in case of very marginal founding soil conditions. Few of the photos given below represent the failure.

**Photo 6 and 7: Case of Deep Seated Failure**
